SALT CREEK / DUPAGE RIVER WORK GROUP

**STREAM DISSOLVED OXYGEN IMPROVEMENT
FEASIBILITY STUDY
FOR
SALT CREEK AND EAST BRANCH OF THE
DUPAGE RIVER**

**DRAFT
EXISTING CONDITIONS DOCUMENT**

DECEMBER, 23 2005

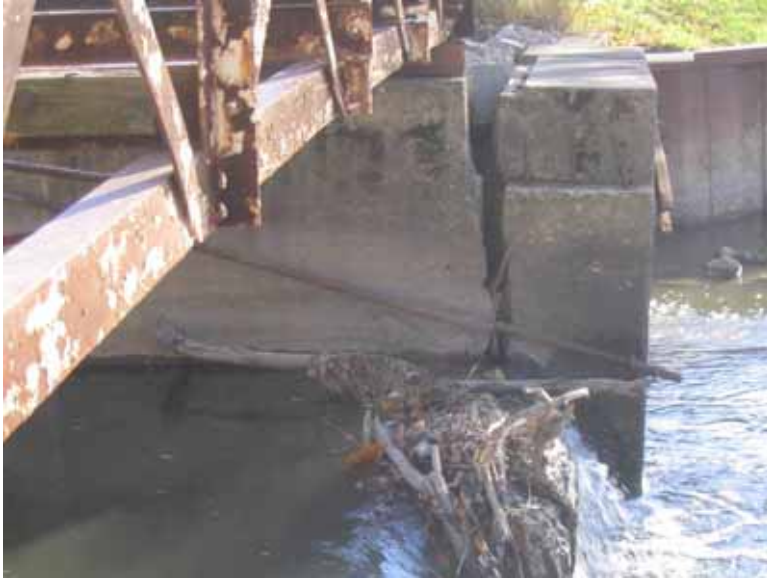
The Structure: The dam spillway appears to be an all concrete structure. The abutments are 2' thick concrete walls with a mixture of materials used as fill. The dam appeared to be in a slightly degraded condition. The left abutment was clearly leaning downstream, and significant cracks have developed in the concrete (Figure 2.1). Previous measures had been taken to correct the problem using reinforcing steel tie rods, anchored to the upstream abutment wall. The same problem and mitigation measures occurred in the right abutment but the wall did not appear to be leaning.

Figure 2.1: Left abutment, significant crack

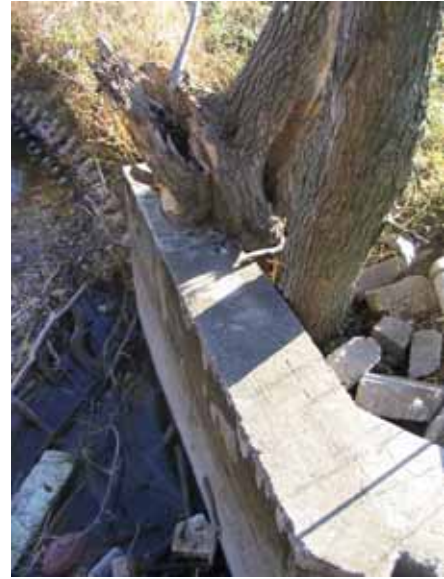
Figure 2.2: Mature tree compromising left training wall

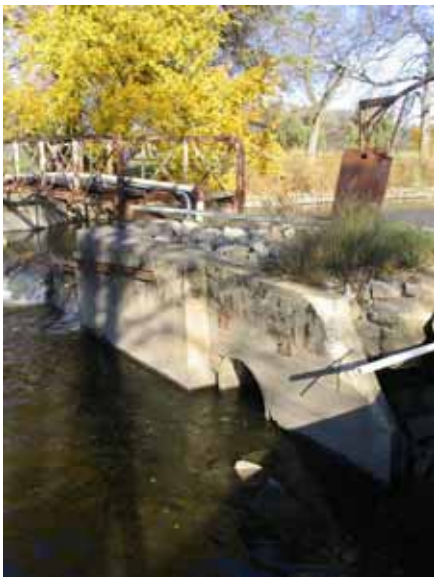
There is a 36" culvert pipe located on the left side of the structure which was clogged on the day of survey with debris. This pipe could provide the means to lower the water surface below the weir elevation of the structure, assuming the capacity was not exceeded by the discharge of the creek at the time.

Figure 2.3: View of left abutment and culvert, the steel gate can be seen in the upper right

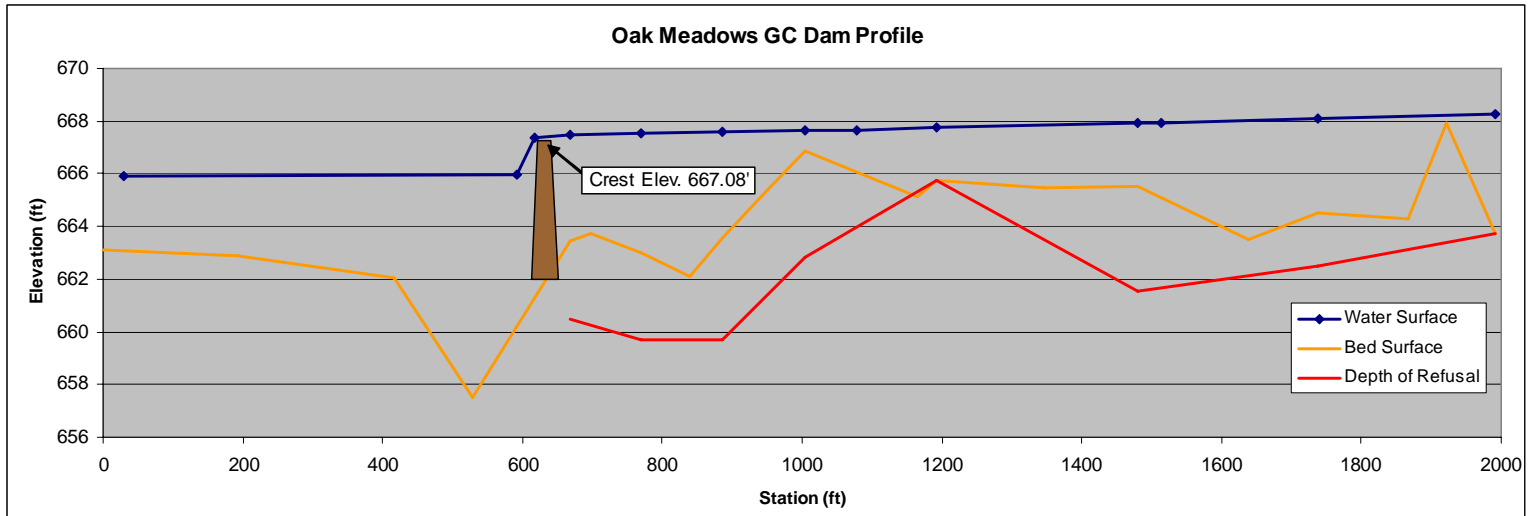
Sediment: An investigation into the amount of sediment upstream of the dam indicated an average of about 2 feet of material in the channel. A total of nine cross sections were taken

beginning just upstream of the dam and extending upstream. Detailed cross sections and locations can be seen in Appendix B. Below is a profile of the survey through the structure.

Sediment has accumulated in areas of low velocity within the stream and is not uniform in its distribution. All of the material consists of semi-consolidated fines. Storage of material within the small impoundment is still occurring as evidenced by the deposition of material in front of recently installed a-jack bank protection measures.

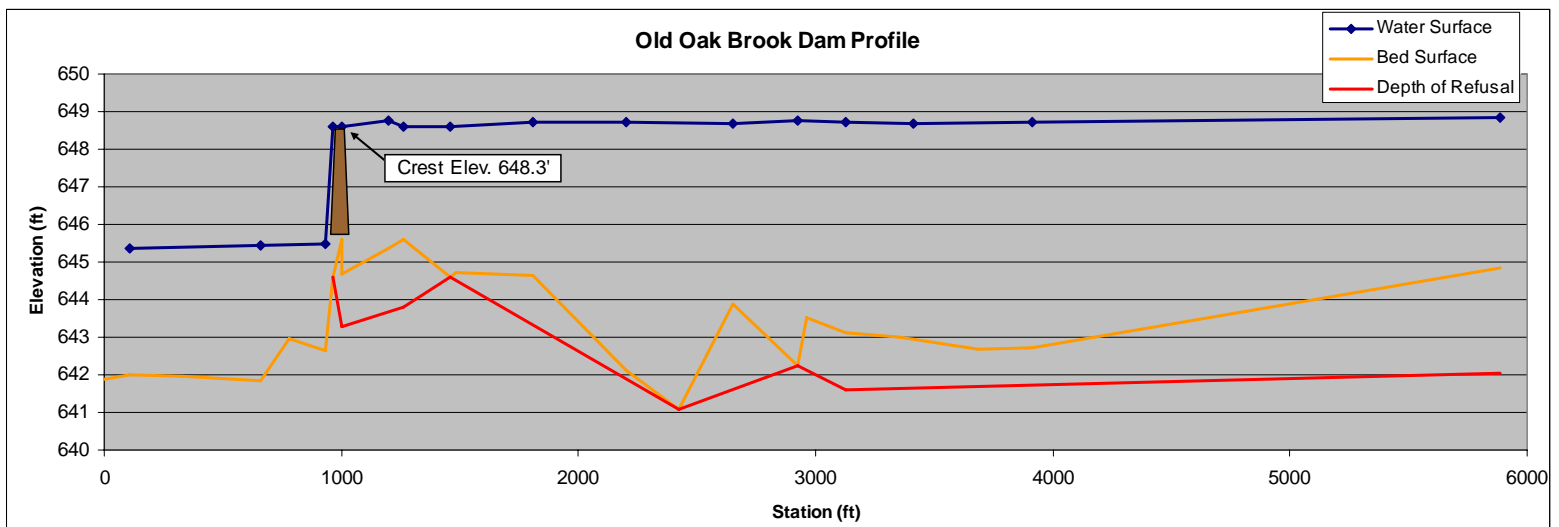
Sediment: Seven cross sections were sampled upstream of the dam to quantify the amount of sediment upstream (details are included in Appendix B). An average of about 1 foot of material was found upstream of the dam, with the largest accumulation just upstream of the left training wall. It is not known how often the sluice gates are opened on the structure but sediment upstream of this inlet was minimal, while downstream, fines had accumulated in the sluice gate channel. Most of the material immediately upstream of the dam was cohesive fines but it quickly coarsened to sands near the 31st St. bridge. There was not an excessive amount of material accumulated behind the dam.

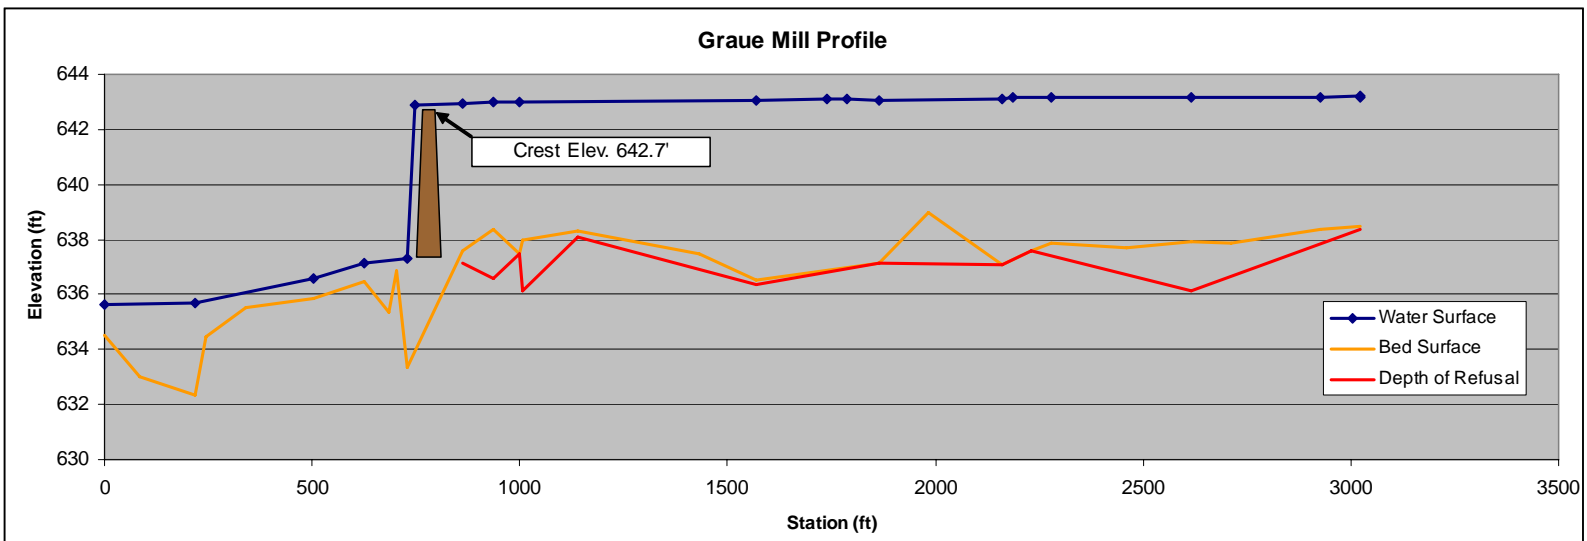
Sediment: Eight cross sections were taken above the Graue Mill dam; detailed information can be viewed in Appendix B. There was generally 1-2' of deposition along the channel margins with often little to no deposition in the thalweg of the channel. This lack of material is likely due to the impact of a dredging project accomplished in the late 1990s. The channel regains its natural thalweg of coarse material approximately 1200' upstream of the dam. The material that is being transported by the stream is depositing in a point bar just downstream of the bend into the Fullersburg Woods property.

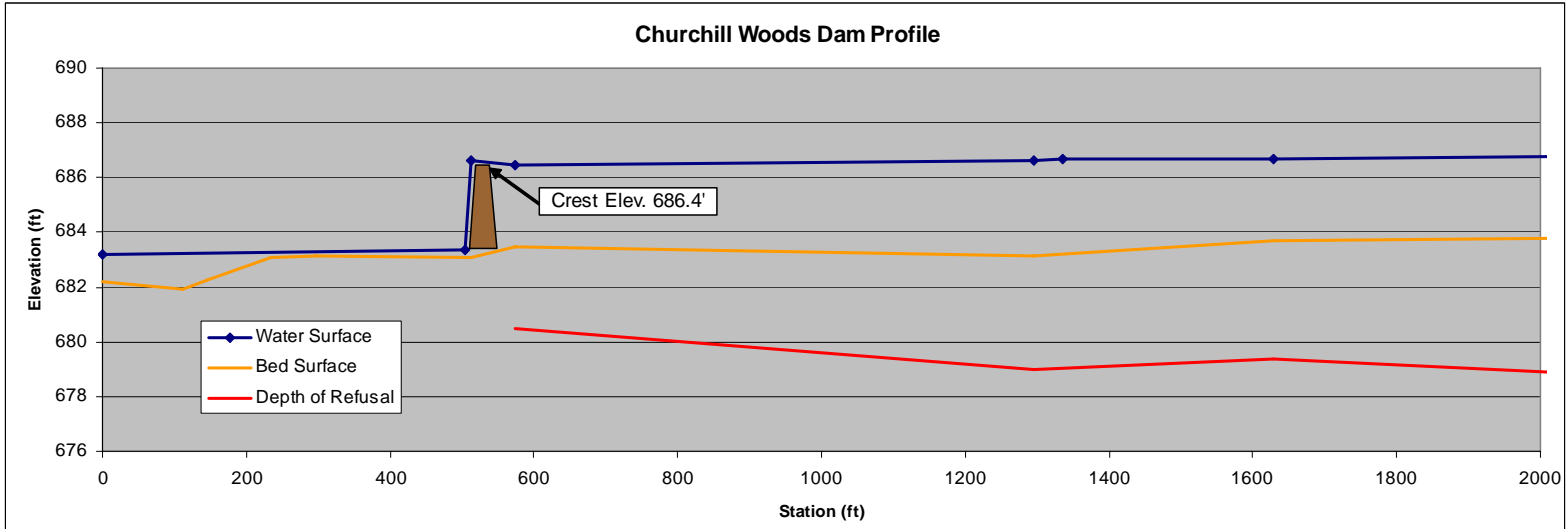
Sediment: The Churchill Dam reservoir contains a large amount of material. The profile shown below indicates nearly 3-4 feet of material consistently blanketing the bed of the reservoir. A number of areas had as much as 7-8' of deposited material. The sediment is made mainly of fine material (silts and clays) and is fairly consolidated in areas where it

is greater than 3' in depth. A total of eight cross sections were surveyed and can be seen in detail in Appendix B. Coarse (small gravel) depositional features were found approximately 1000' upstream of the St Charles bridge, indicating this may be the extent of the delta formed as a result of the impoundment.
