**SALT CREEK / DUPAGE RIVER WORK GROUP**

**STREAM DISSOLVED OXYGEN IMPROVEMENT  
FEASIBILITY STUDY  
FOR  
SALT CREEK AND EAST BRANCH OF THE  
DUPAGE RIVER**

**DRAFT  
EXISTING CONDITIONS DOCUMENT**

**DECEMBER, 23 2005**

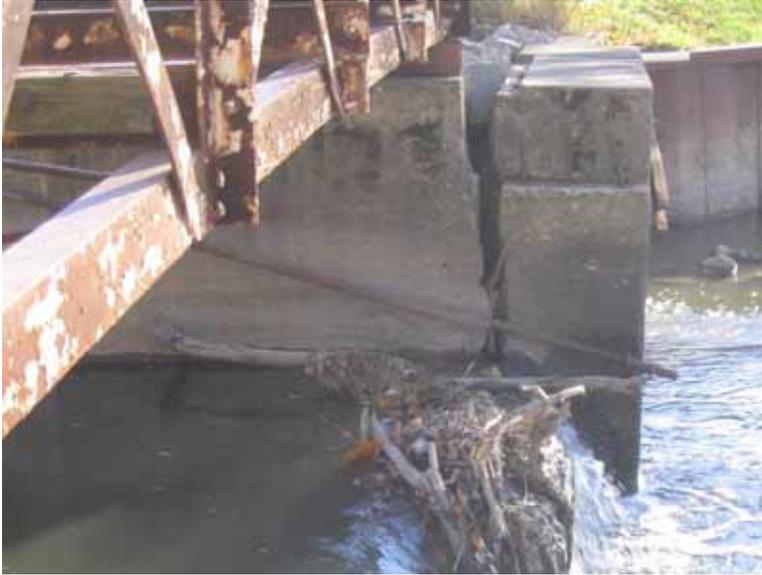
**The Structure:** The dam spillway appears to be an all concrete structure. The abutments are 2' thick concrete walls with a mixture of materials used as fill. The dam appeared to be in a slightly degraded condition. The left abutment was clearly leaning downstream, and significant cracks have developed in the concrete (Figure 2.1). Previous measures had been taken to correct the problem using reinforcing steel tie rods, anchored to the upstream abutment wall. The same problem and mitigation measures occurred in the right abutment but the wall did not appear to be leaning.

**Figure 2.1: Left abutment, significant crack**

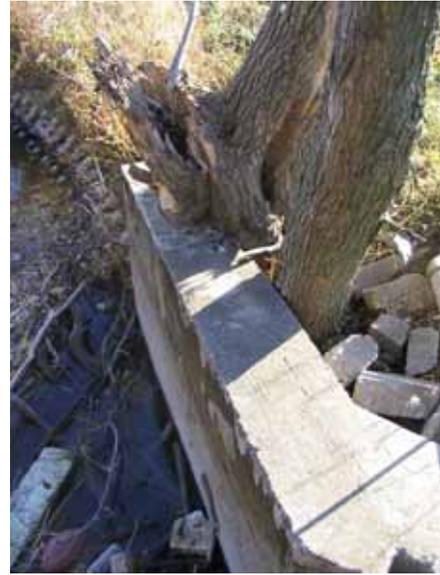
**Figure 2.2: Mature tree compromising left training wall**

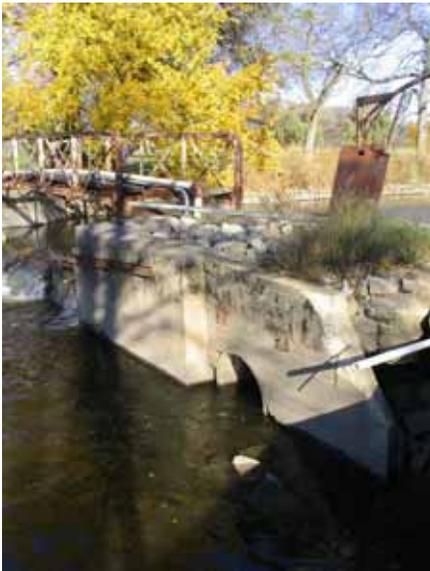
There is a 36" culvert pipe located on the left side of the structure which was clogged on the day of survey with debris. This pipe could provide the means to lower the water surface below the weir elevation of the structure, assuming the capacity was not exceeded by the discharge of the creek at the time.

**Figure 2.3: View of left abutment and culvert, the steel gate can be seen in the upper right**

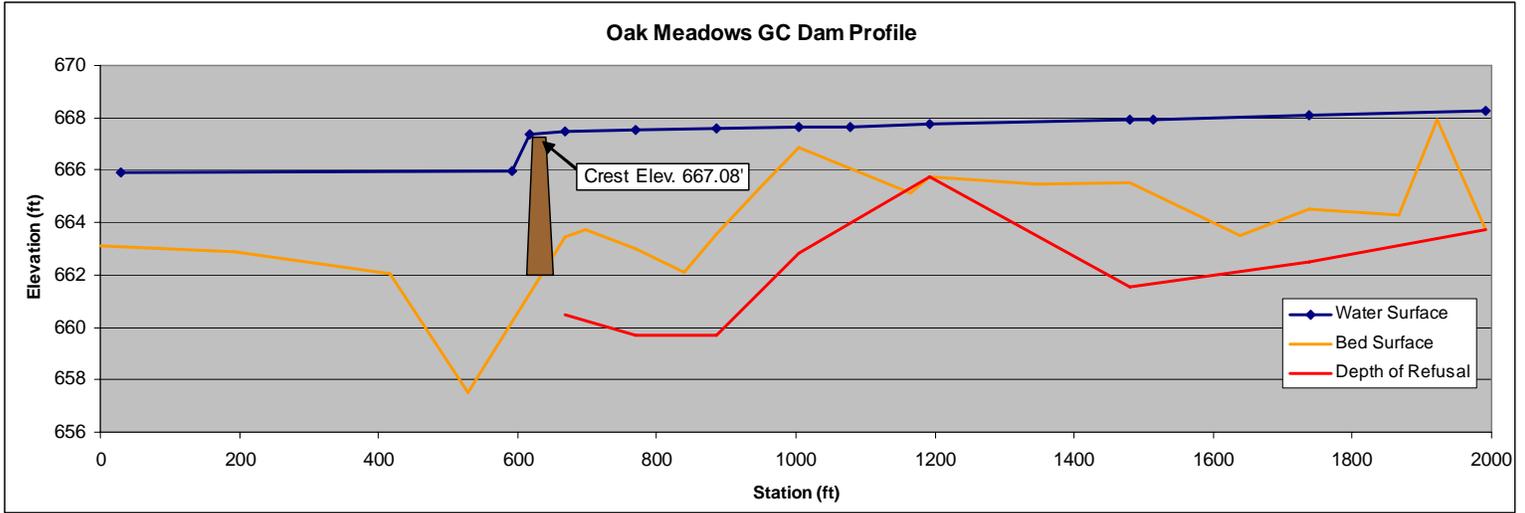
**Sediment:** An investigation into the amount of sediment upstream of the dam indicated an average of about 2 feet of material in the channel. A total of nine cross sections were taken

beginning just upstream of the dam and extending upstream. Detailed cross sections and locations can be seen in Appendix B. Below is a profile of the survey through the structure.

Sediment has accumulated in areas of low velocity within the stream and is not uniform in its distribution. All of the material consists of semi-consolidated fines. Storage of material within the small impoundment is still occurring as evidenced by the deposition of material in front of recently installed a-jack bank protection measures.

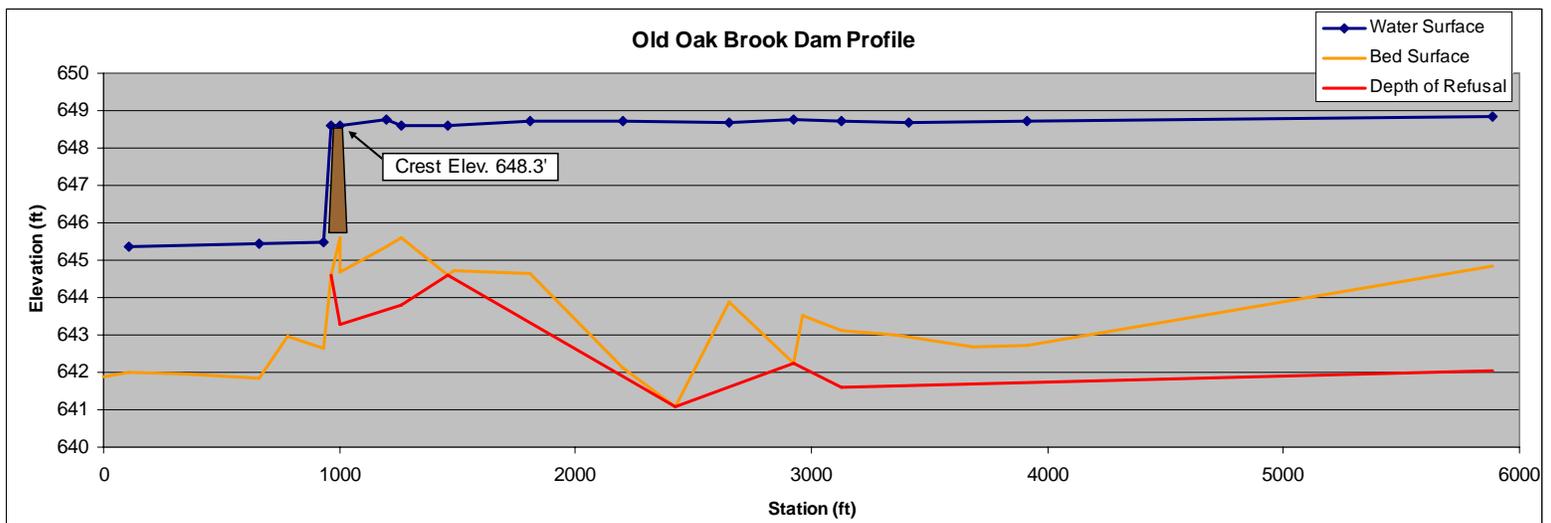
**Sediment:** Seven cross sections were sampled upstream of the dam to quantify the amount of sediment upstream (details are included in Appendix B). An average of about 1 foot of material was found upstream of the dam, with the largest accumulation just upstream of the left training wall. It is not known how often the sluice gates are opened on the structure but sediment upstream of this inlet was minimal, while downstream, fines had accumulated in the sluice gate channel. Most of the material immediately upstream of the dam was cohesive fines but it quickly coarsened to sands near the 31<sup>st</sup> St. bridge. There was not an excessive amount of material accumulated behind the dam.

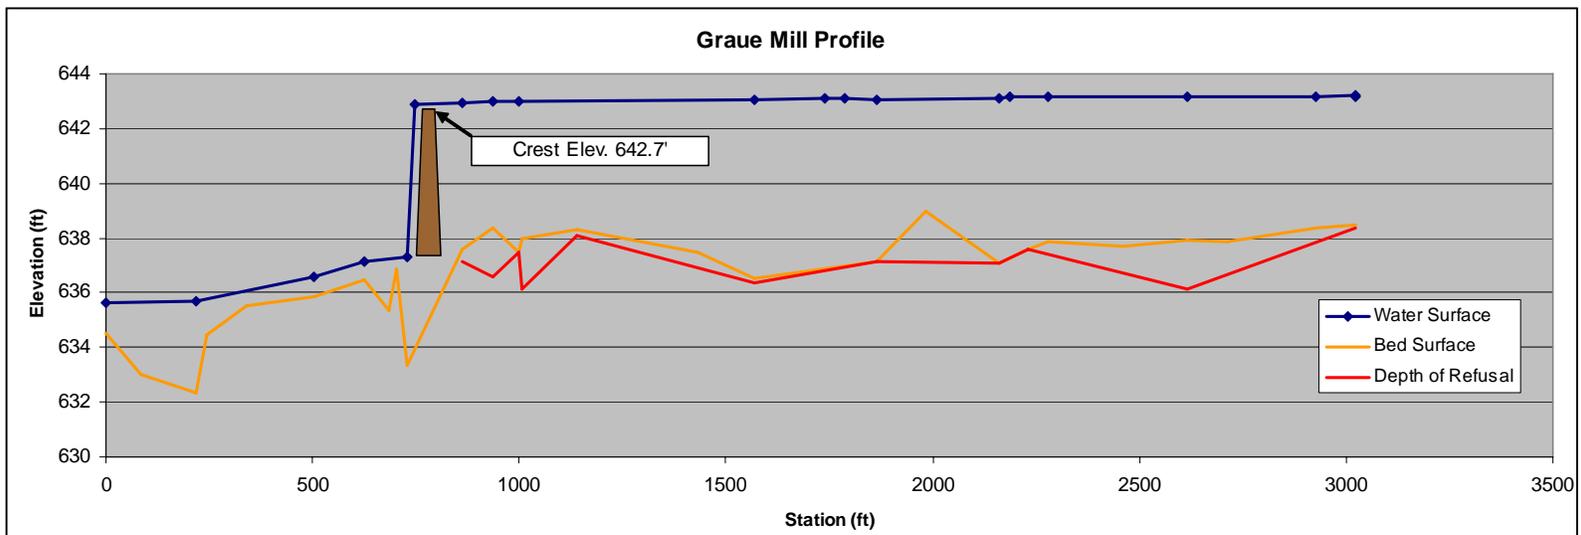
**Sediment:** Eight cross sections were taken above the Graue Mill dam; detailed information can be viewed in Appendix B. There was generally 1-2' of deposition along the channel margins with often little to no deposition in the thalweg of the channel. This lack of material is likely due to the impact of a dredging project accomplished in the late 1990s. The channel regains its natural thalweg of coarse material approximately 1200' upstream of the dam. The material that is being transported by the stream is depositing in a point bar just downstream of the bend into the Fullersburg Woods property.

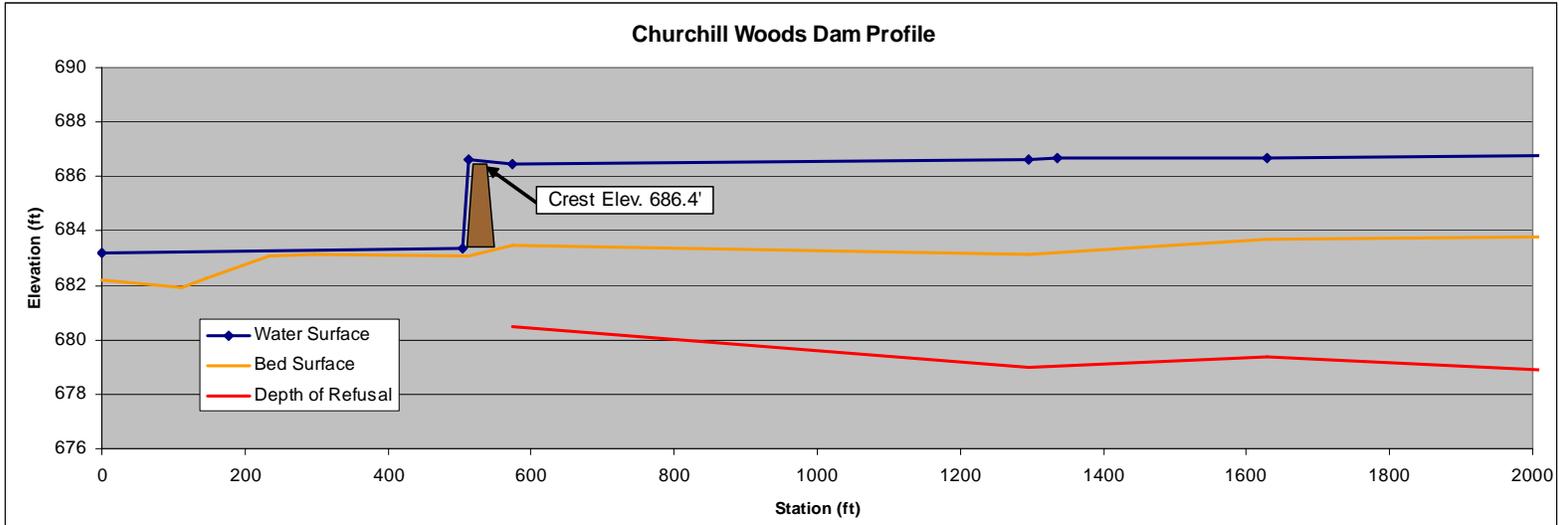
**Sediment:** The Churchill Dam reservoir contains a large amount of material. The profile shown below indicates nearly 3-4 feet of material consistently blanketing the bed of the reservoir. A number of areas had as much as 7-8' of deposited material. The sediment is made mainly of fine material (silts and clays) and is fairly consolidated in areas where it

is greater than 3' in depth. A total of eight cross sections were surveyed and can be seen in detail in Appendix B. Coarse (small gravel) depositional features were found approximately 1000' upstream of the St Charles bridge, indicating this may be the extent of the delta formed as a result of the impoundment.
