SALT CREEK / DUPAGE RIVER WORK GROUP

**STREAM DISSOLVED OXYGEN IMPROVEMENT
FEASIBILITY STUDY
FOR
SALT CREEK AND EAST BRANCH OF THE
DUPAGE RIVER**

**DRAFT
EXISTING CONDITIONS DOCUMENT**

DECEMBER, 23 2005

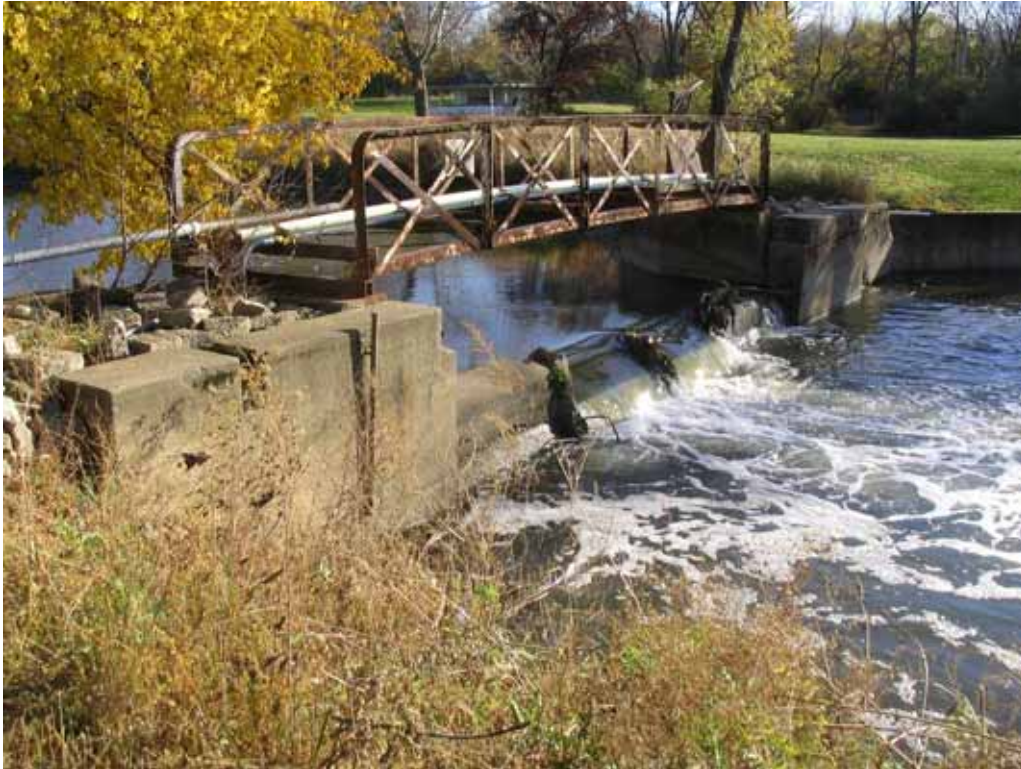
2.3.1 Oak Meadows Golf Course Dam

Hydraulic Impact: Although not specifically evaluated, because of the low elevation of the structure, the hydraulic impacts to storm water storage during flood events are expected to be minor. However, at low flows, the dam maintains a fairly constant pool elevation upstream of the structure that persists for quite a distance because of the low gradient.

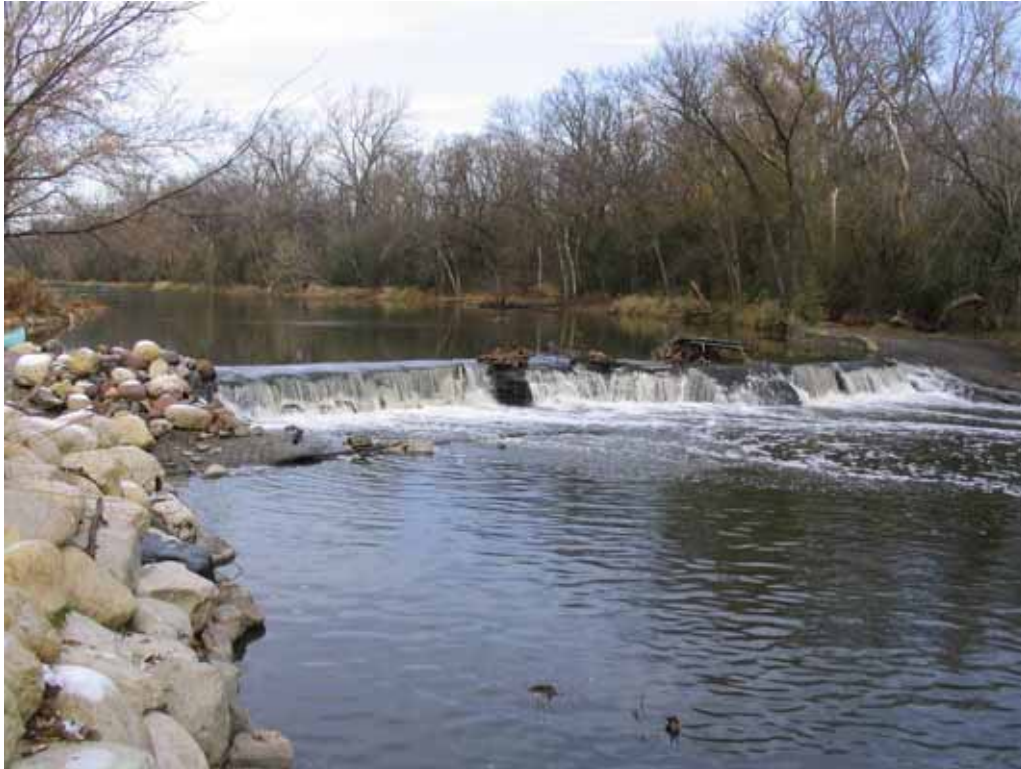
2.3.2 Old Oak Brook Dam

Hydraulic Impacts: Hydraulic computations compiled by a number of studies indicate that the backwater effect of the dam stretches up to approximately 31st street during small flood events (<10 yr event) and 22nd street during events higher than a 10 yr event. The storage provided by the dam is minimal.

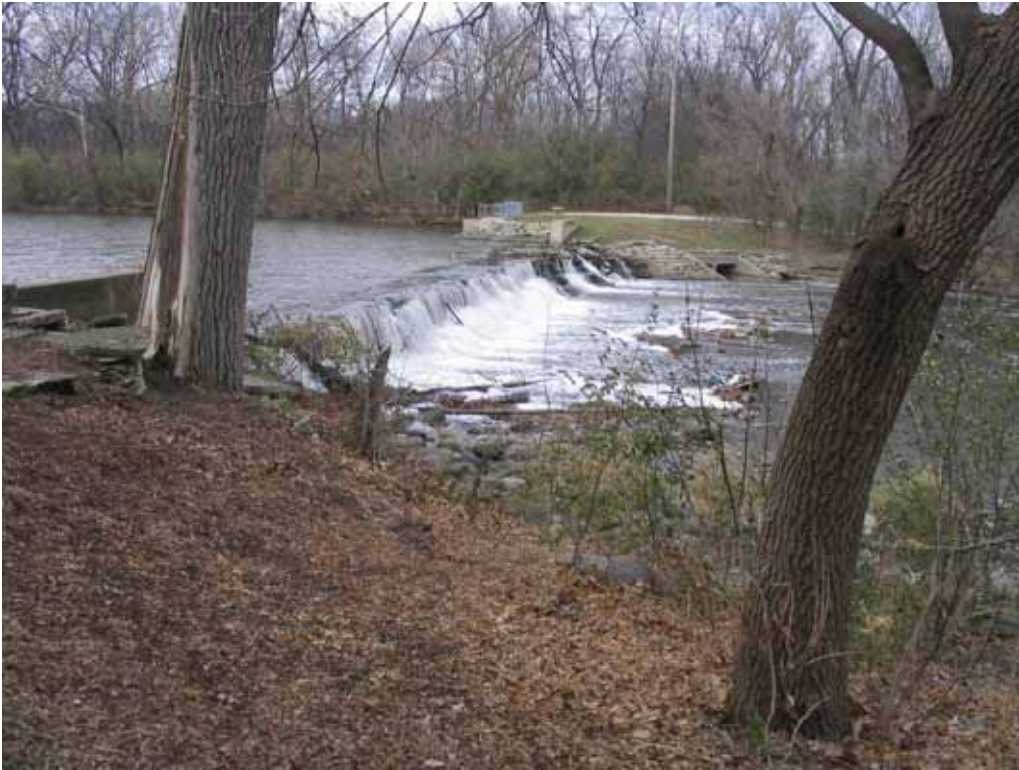
2.3.3 Fullersburg Woods Dam

Hydraulic Impacts: The hydraulic impacts of the dam reach through the Forest Preserve District Property upstream but do not continue past 31st St. The removal of the dam would result in a little over 1.0 feet of reduced flood elevation through the 100 year event, according to previous calculations performed by the Forest Preserve District, prior to the new updated FEQ model. In terms of storm water storage, the reservoir provides little capacity and a general consensus among review reports indicates the dam has little value in flood mitigation. Detailed results of the FEQ modeling effort have not been evaluated at this time, though all indications suggest an expected minimal role of the dam in regional storm water mitigation.

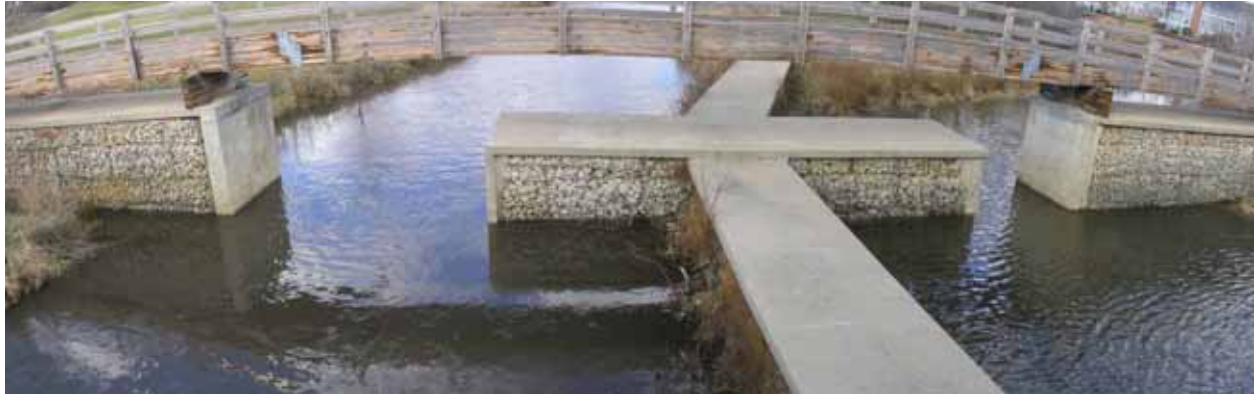
2.3.4 EB DuPage / Prentiss Creek Dam(s)

Hydraulic Impacts: Details are forthcoming, however the project was designed to provide flood storage and compensatory mitigation for the associated development so there is most certainly an impact at a range of flood events.

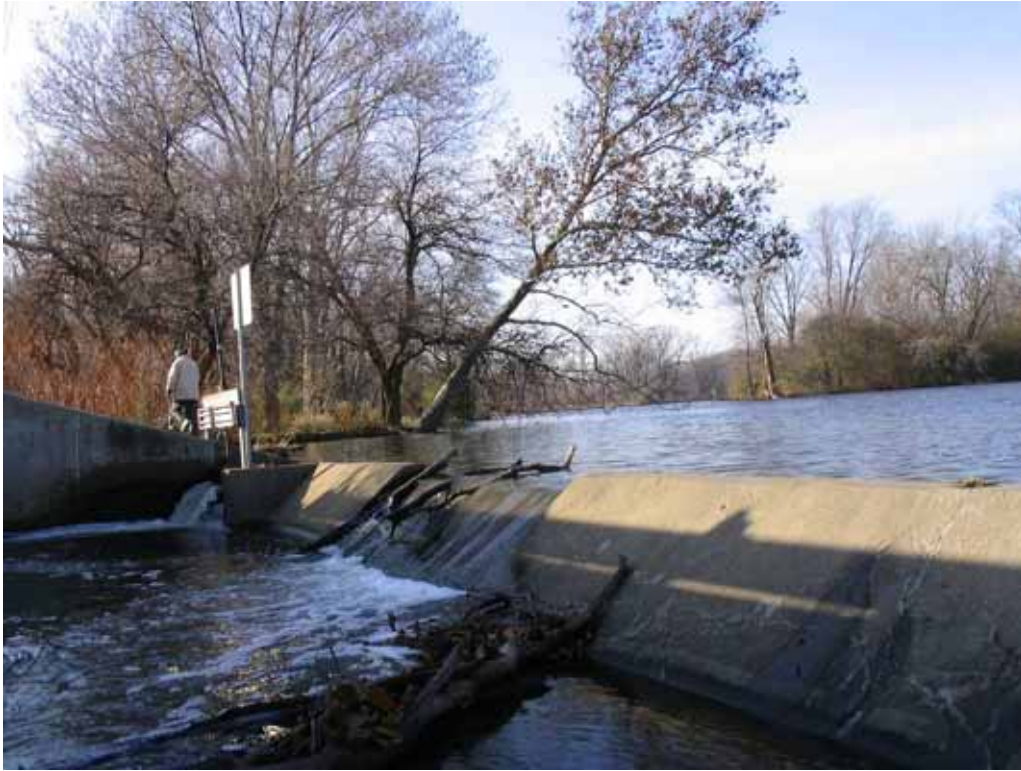
2.3.5 Churchill Woods Dam

Year Constructed: Unknown. Significant improvements were made to the structure as part of the Crescent Blvd. re-design in 1983. Local residents state it was a WPA project, likely built in the 1930s for flood control.
