**SALT CREEK / DUPAGE RIVER WORK GROUP**

**STREAM DISSOLVED OXYGEN IMPROVEMENT  
FEASIBILITY STUDY  
FOR  
SALT CREEK AND EAST BRANCH OF THE  
DUPAGE RIVER**

**DRAFT  
EXISTING CONDITIONS DOCUMENT**

**DECEMBER, 23 2005**

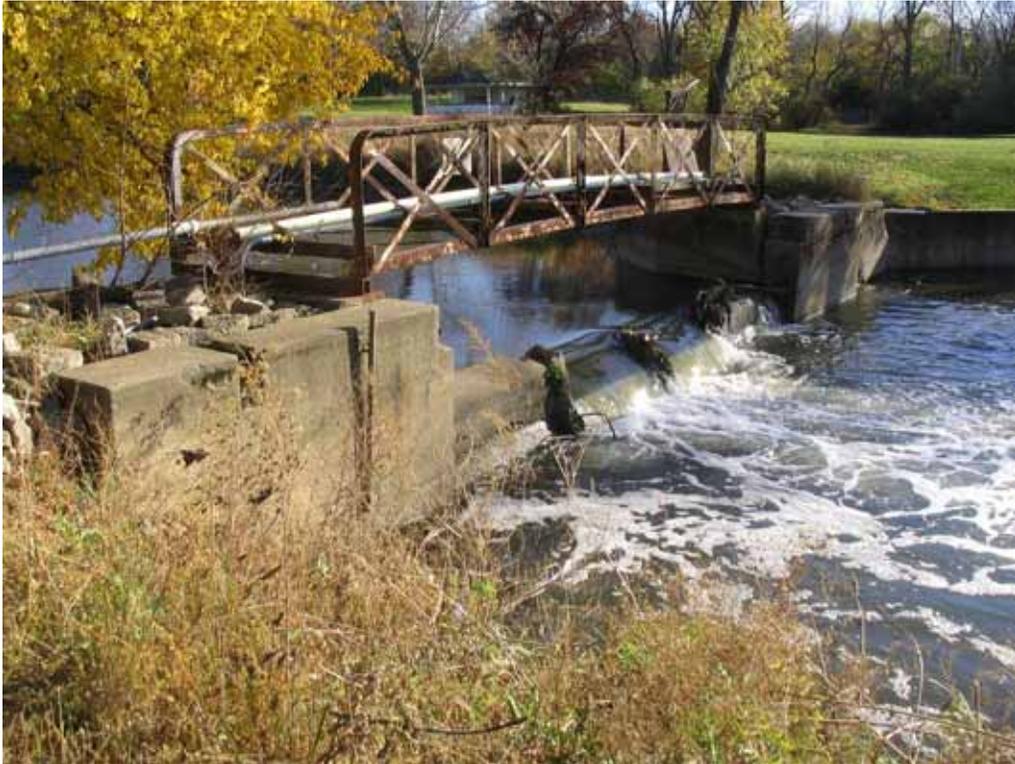
### 2.3.1 Oak Meadows Golf Course Dam

**Hydraulic Impact:** Although not specifically evaluated, because of the low elevation of the structure, the hydraulic impacts to storm water storage during flood events are expected to be minor. However, at low flows, the dam maintains a fairly constant pool elevation upstream of the structure that persists for quite a distance because of the low gradient.

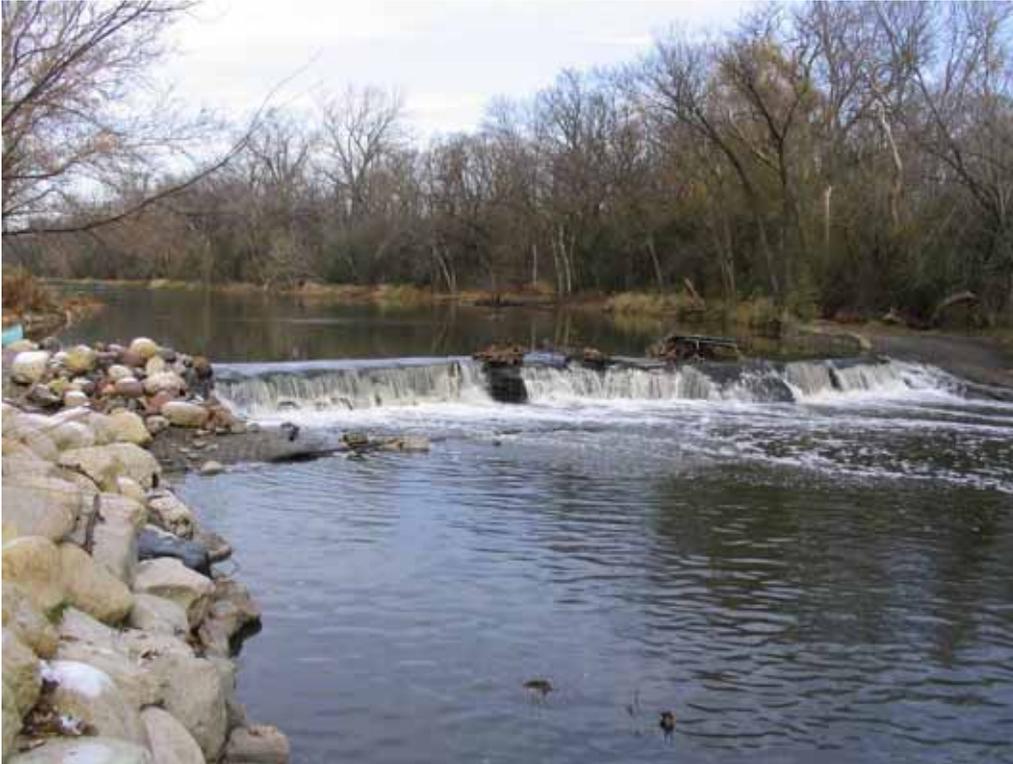
### 2.3.2 Old Oak Brook Dam

**Hydraulic Impacts:** Hydraulic computations compiled by a number of studies indicate that the backwater effect of the dam stretches up to approximately 31<sup>st</sup> street during small flood events (<10 yr event) and 22<sup>nd</sup> street during events higher than a 10 yr event. The storage provided by the dam is minimal.

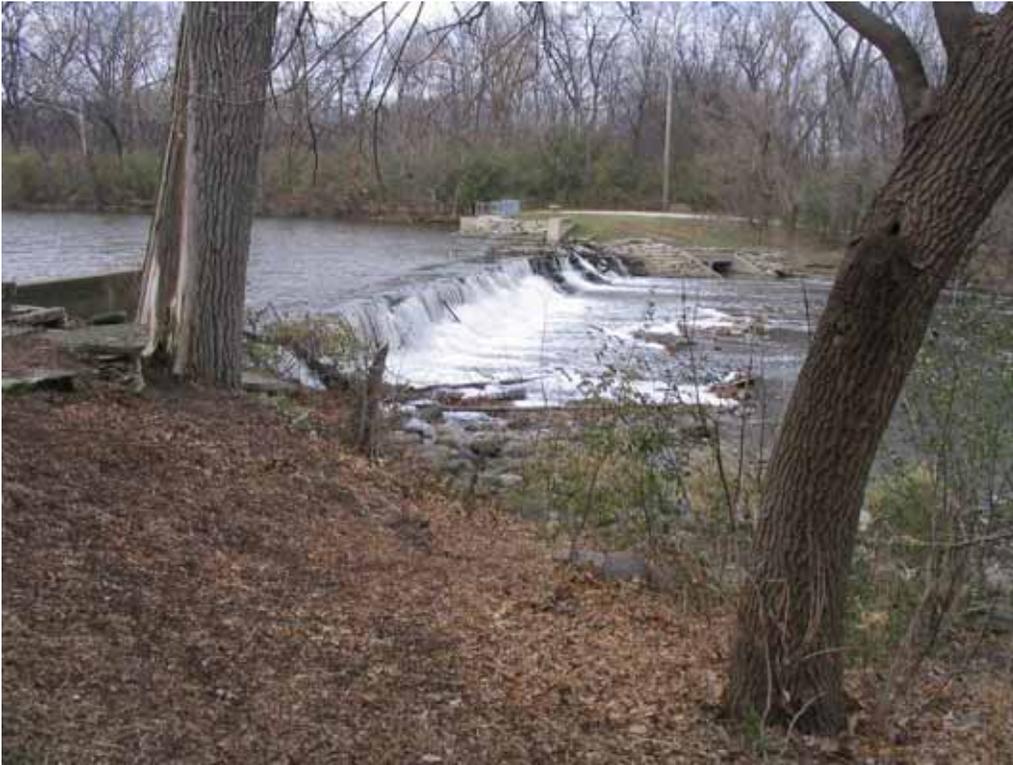
### 2.3.3 Fullersburg Woods Dam

**Hydraulic Impacts:** The hydraulic impacts of the dam reach through the Forest Preserve District Property upstream but do not continue past 31<sup>st</sup> St. The removal of the dam would result in a little over 1.0 feet of reduced flood elevation through the 100 year event, according to previous calculations performed by the Forest Preserve District, prior to the new updated FEQ model. In terms of storm water storage, the reservoir provides little capacity and a general consensus among review reports indicates the dam has little value in flood mitigation. Detailed results of the FEQ modeling effort have not been evaluated at this time, though all indications suggest an expected minimal role of the dam in regional storm water mitigation.

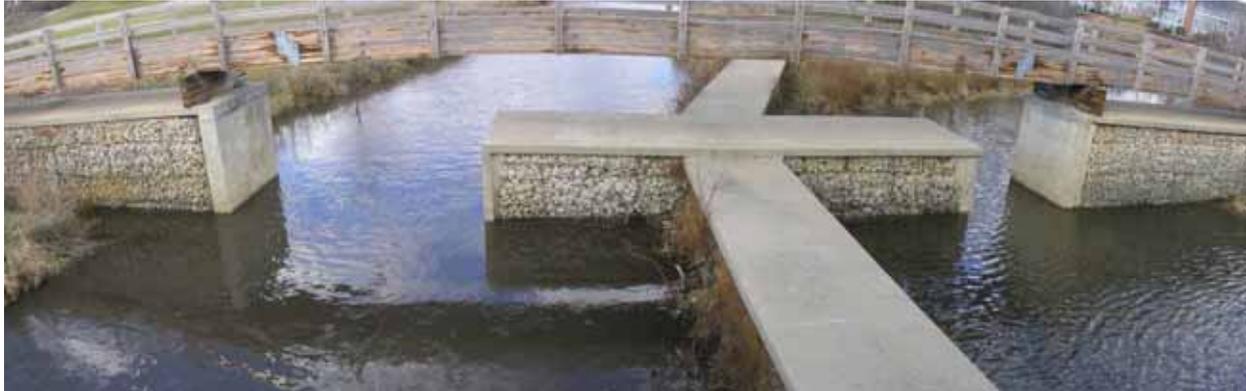
### 2.3.4 EB DuPage / Prentiss Creek Dam(s)

**Hydraulic Impacts:** Details are forthcoming, however the project was designed to provide flood storage and compensatory mitigation for the associated development so there is most certainly an impact at a range of flood events.

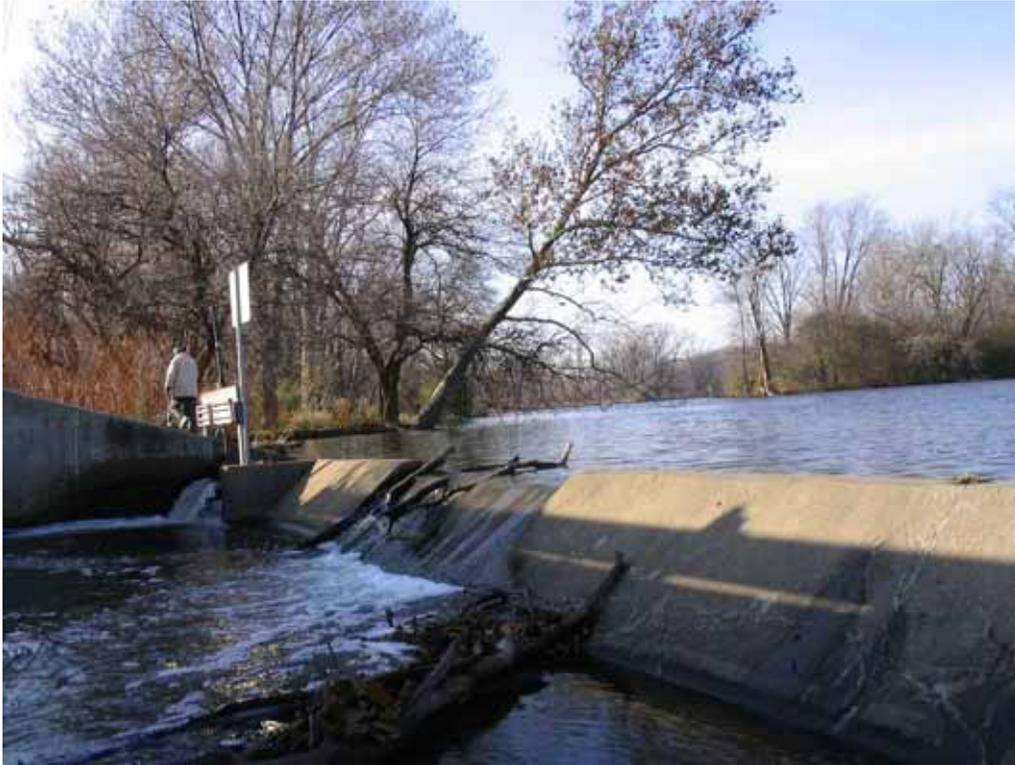
### 2.3.5 Churchill Woods Dam

**Year Constructed:** Unknown. Significant improvements were made to the structure as part of the Crescent Blvd. re-design in 1983. Local residents state it was a WPA project, likely built in the 1930s for flood control.
